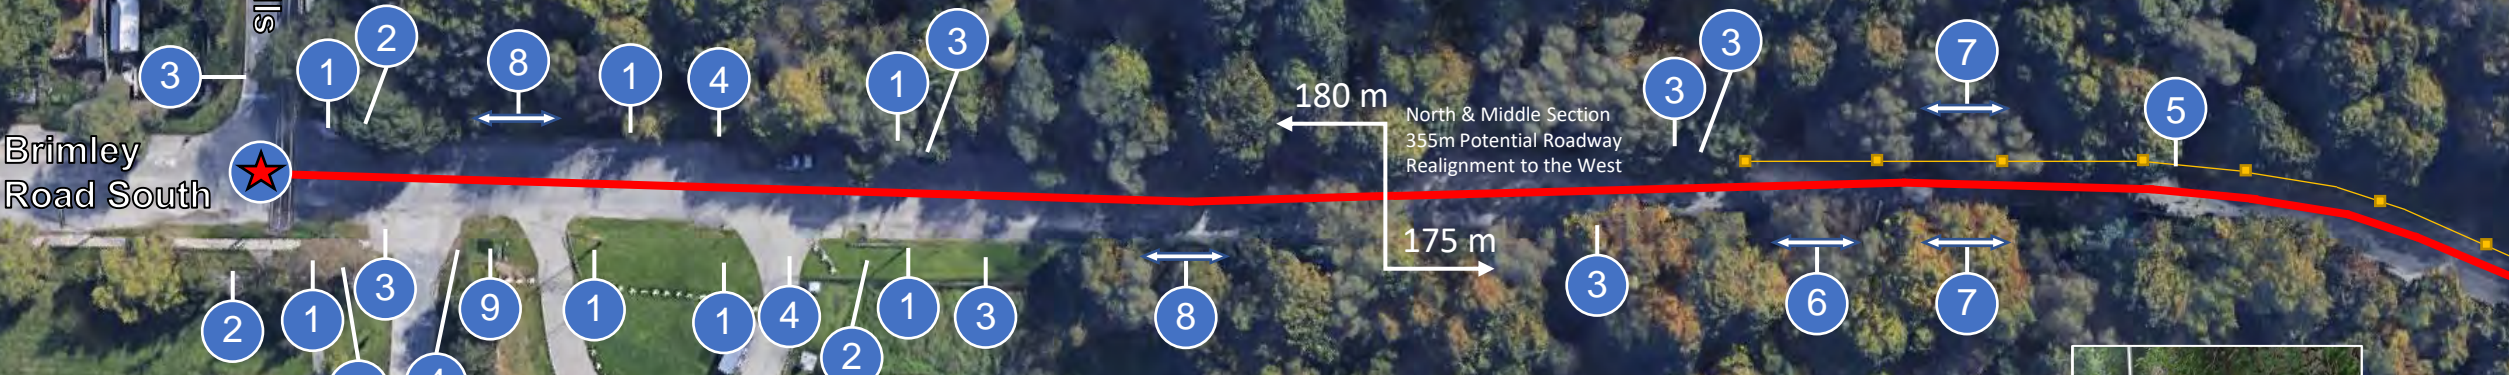
<b>7</b> Mature Trees. Vegetation/trees will require removal for MUP/realignment of road	<b>8</b> Stormwater interceptor swale on both the west and east side of Brimley Road South	<b>9</b> Bluffer's Park Sign

Property Acquisition (6.5m from rear of 10 properties on 50 - 30 Larwood Blvd. to accommodate MUP on the east side. Retaining wall will be required between MUP and property line due to steep grade drop. Guardrail may be required atop of retaining wall for cyclist and pedestrian safety)

**★** Intersection Improvement: Pedestrian and cycling safety and seamless transition from on/off cycling facilities. Pavement Markings

**1** Utility poles and/or guy anchors, Street Lights will require relocation as a result of MUP/realignment of Brimley Rd to the West

**2** Utility pedestal/ Handholes may require relocation as a result of MUP/realignment of Brimley Rd to the West

**3** Sanitary/storm man holes and catch basins may require relocation/ adjustments ( boulevard/ swale/roadway)

**4** Entrance culvert may need replacement and relocation (Various locations - crushed pipe at outlets)

**5** Guiderail removal/replacement to accommodate MUP

**6** Gabion wall impacts with road realignment to the west, and steep embankments. Limited cut into walls due to capped former landfill

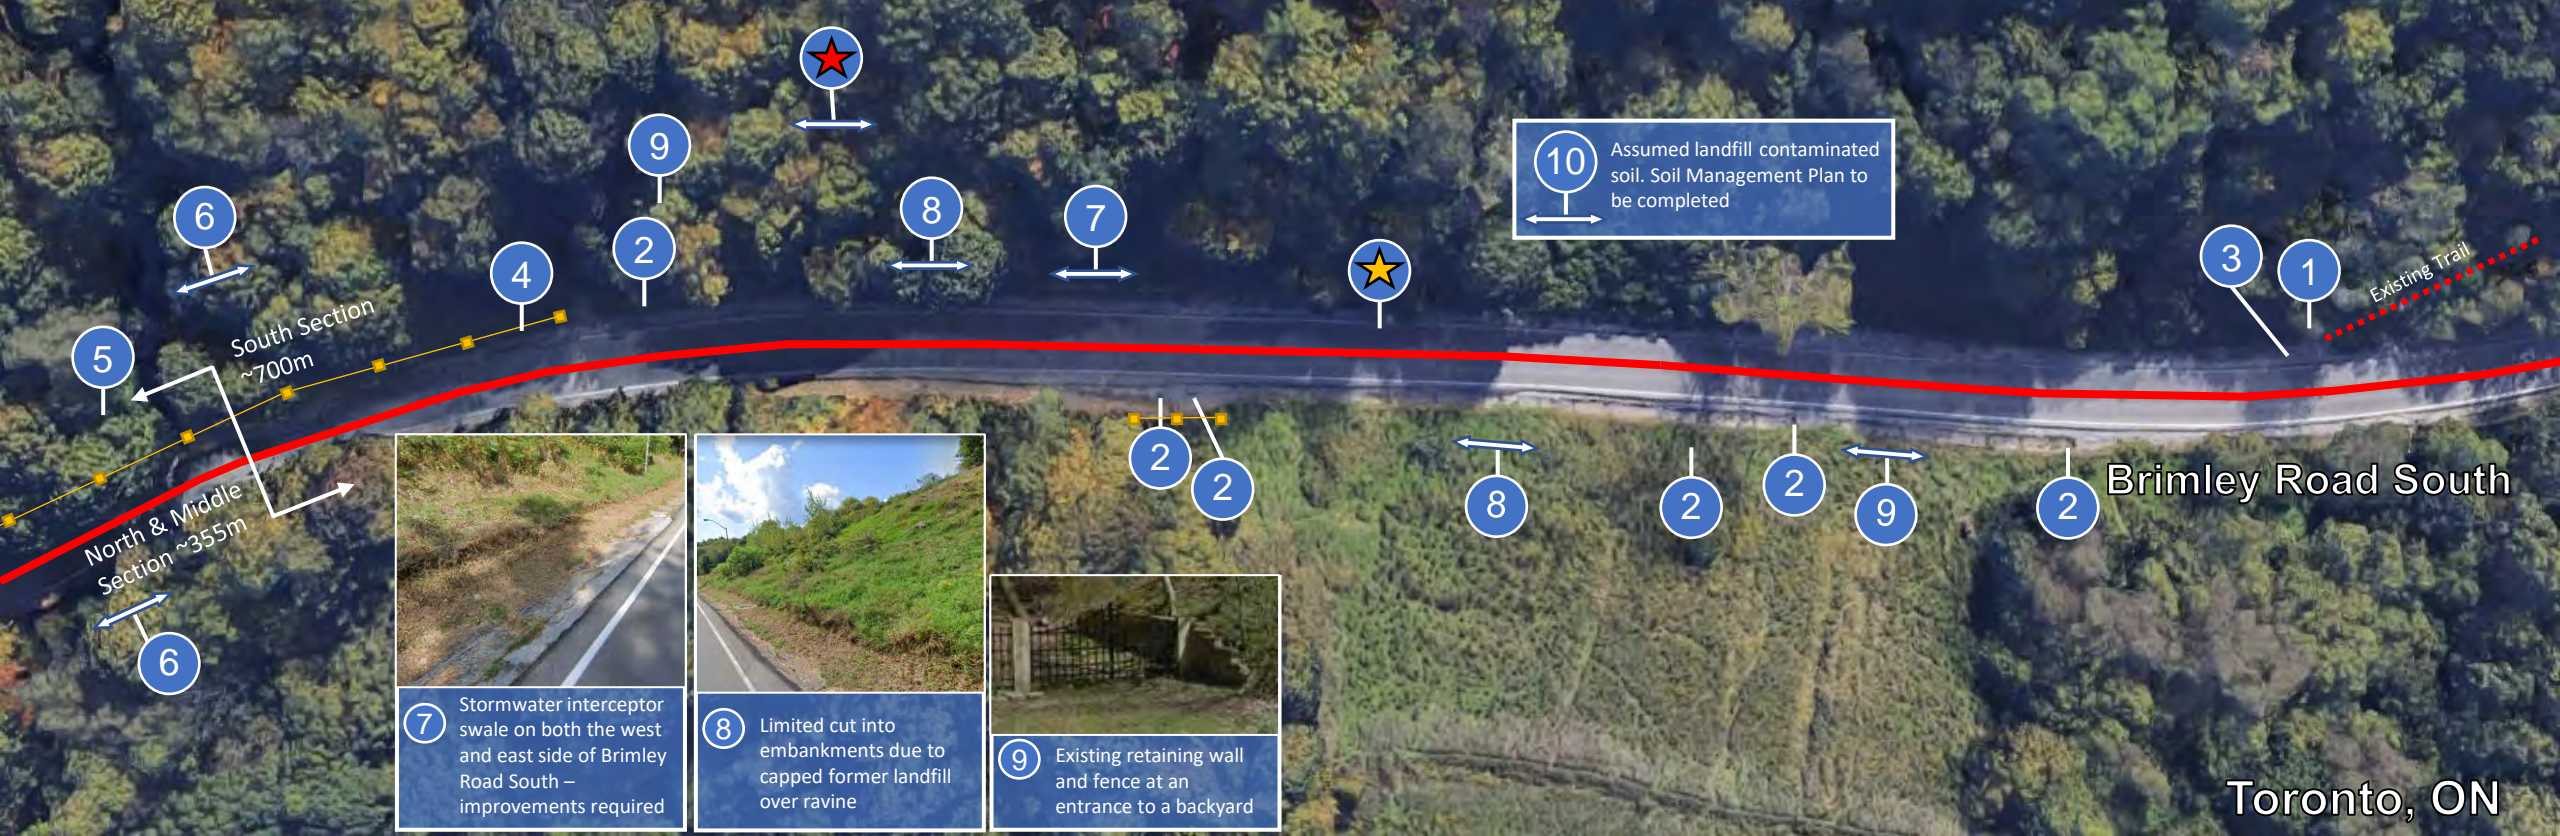
<b>★</b> Steep road grades of 9.47%, proposed MUP to match existing grades will not be AODA compliant and require improvements/justification	<b>★</b> Houses with decks at the top of the embankment. Pre-construction inspection, stability and vibration monitoring will be required	<b>1</b> MUP will transition and follow existing trail. Improvements/barriers/guardrail may be implemented to improve safety and restrict vehicular access to trail	<b>2</b> Catch basin/ man holes may require adjustments. Catch basins are being clogged by leaves and debris within swale	<b>3</b> Entrance/cross culvert may need replacement and relocation (various locations – crushed pipe at outlets)	<b>4</b> Guidesail removal/replacement to accommodate MUP	<b>5</b> Wildlife. Deer was spotted during site visit. Design and construction will consider safety of trail users as well as well being of wild life in the park	<b>6</b> Vegetation/trees will require removal for MUP and realignment of 355m of Brimley Road

**10** Assumed landfill contaminated soil. Soil Management Plan to be completed

**7** Stormwater interceptor swale on both the west and east side of Brimley Road South – improvements required

**8** Limited cut into embankments due to capped former landfill over ravine

**9** Existing retaining wall and fence at an entrance to a backyard

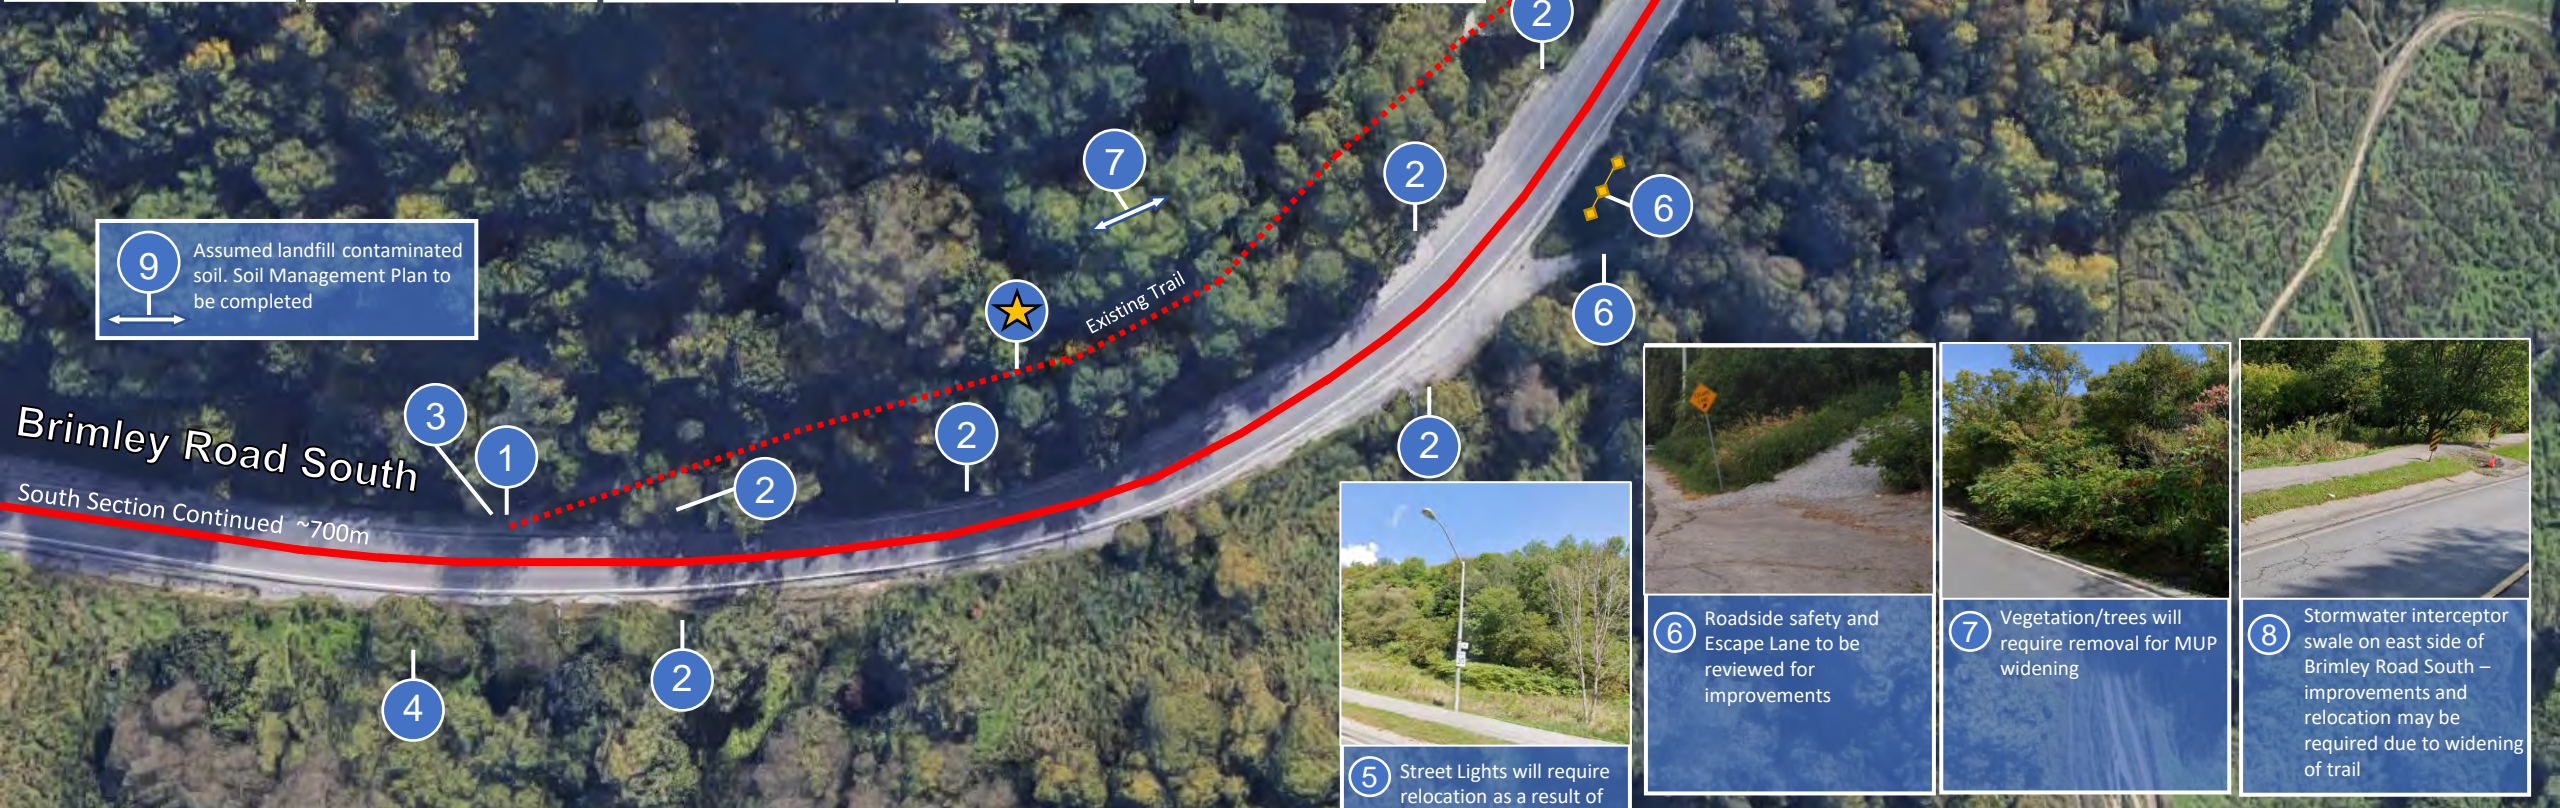
★ Steep trail grades between 6.3% to 17.0%. MUP to match existing grades will not be AODA compliant and require improvements/ landings/ justification

1 Existing concrete barriers susceptible to graffiti and vandalism in the past. Roadside safety - other options for guards at the entrances will be considered

2 Catch basins/ manholes /ditch inlets may require adjustments. Catch basins are being clogged by leaves and debris within swale

3 Entrance/cross pathway culverts may need replacement an/or relocation

4 Toronto Hydro Pad Mounted Transformer

9 Assumed landfill contaminated soil. Soil Management Plan to be completed

6 Roadside safety and Escape Lane to be reviewed for improvements

7 Vegetation/trees will require removal for MUP widening

8 Stormwater interceptor swale on east side of Brimley Road South – improvements and relocation may be required due to widening of trail

5 Street Lights will require relocation as a result of trail widening

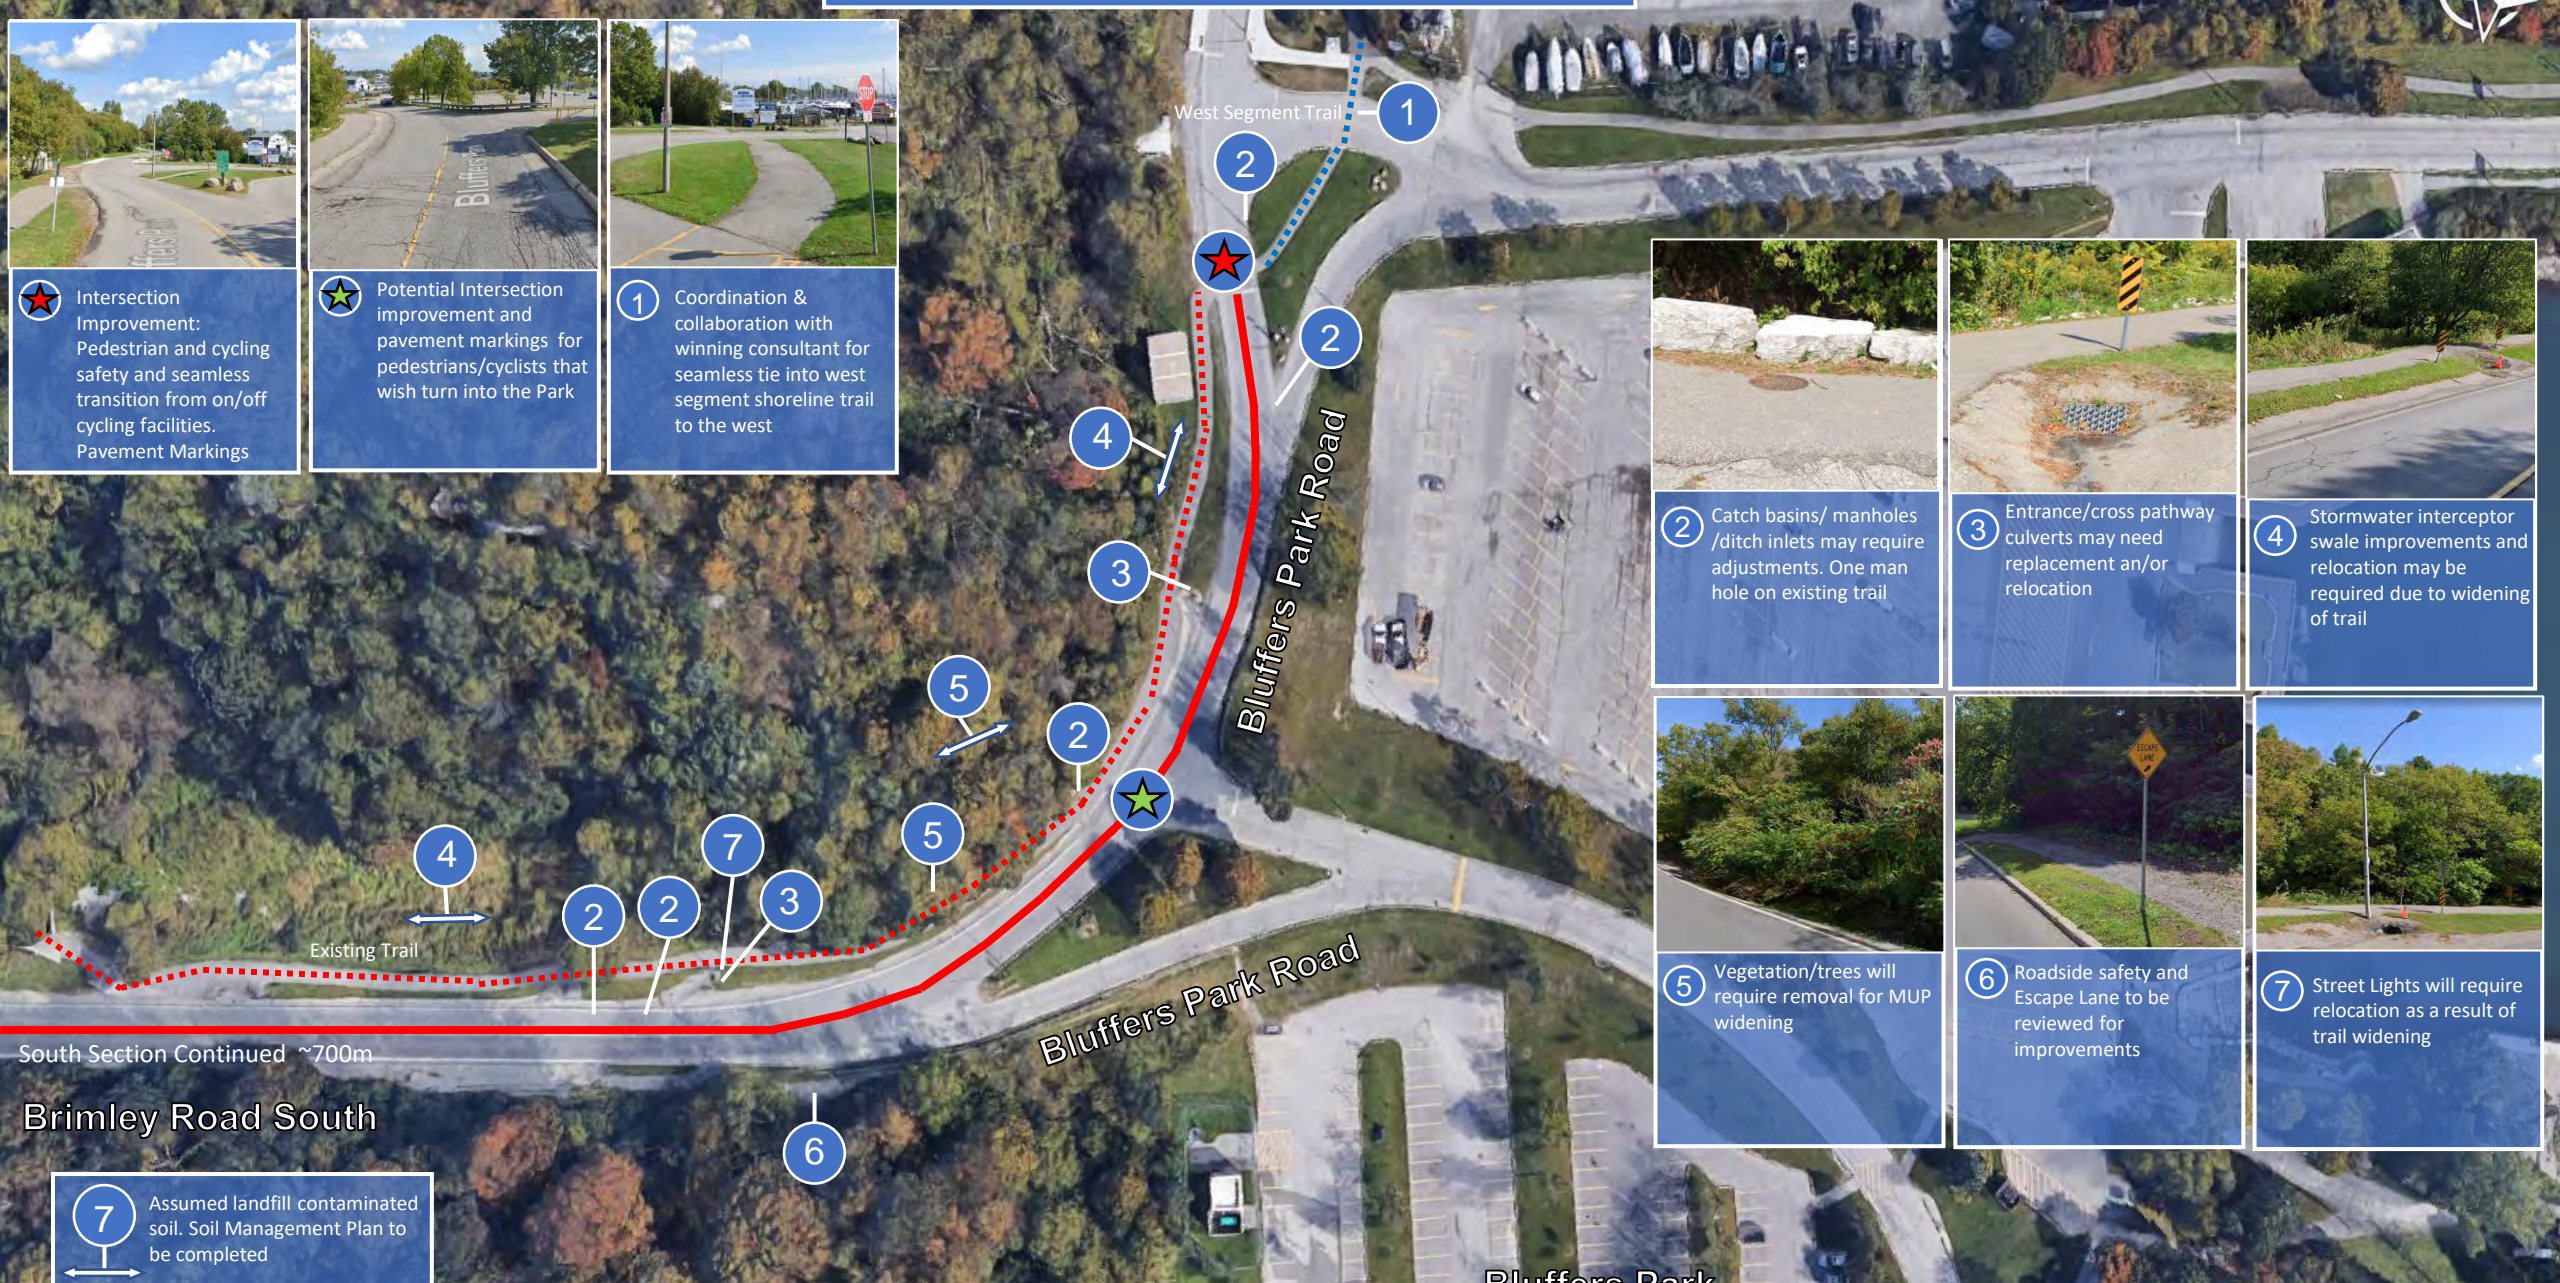
**★** Intersection Improvement: Pedestrian and cycling safety and seamless transition from on/off cycling facilities. Pavement Markings

**★** Potential Intersection improvement and pavement markings for pedestrians/cyclists that wish turn into the Park

**1** Coordination & collaboration with winning consultant for seamless tie into west segment shoreline trail to the west

**2** Catch basins/ manholes /ditch inlets may require adjustments. One man hole on existing trail

**3** Entrance/cross pathway culverts may need replacement an/or relocation

**4** Stormwater interceptor swale improvements and relocation may be required due to widening of trail

**5** Vegetation/trees will require removal for MUP widening

**6** Roadside safety and Escape Lane to be reviewed for improvements

**7** Street Lights will require relocation as a result of trail widening

**7** Assumed landfill contaminated soil. Soil Management Plan to be completed
