# AJAX WATERFRONT SHORELINE ASSESSMENT AND GAP ANALYSIS

Review of Existing Conditions and Identification of  
Information Gaps  
Prepared for the Town of Ajax

**FINAL REPORT**  
MARCH 16, 2022

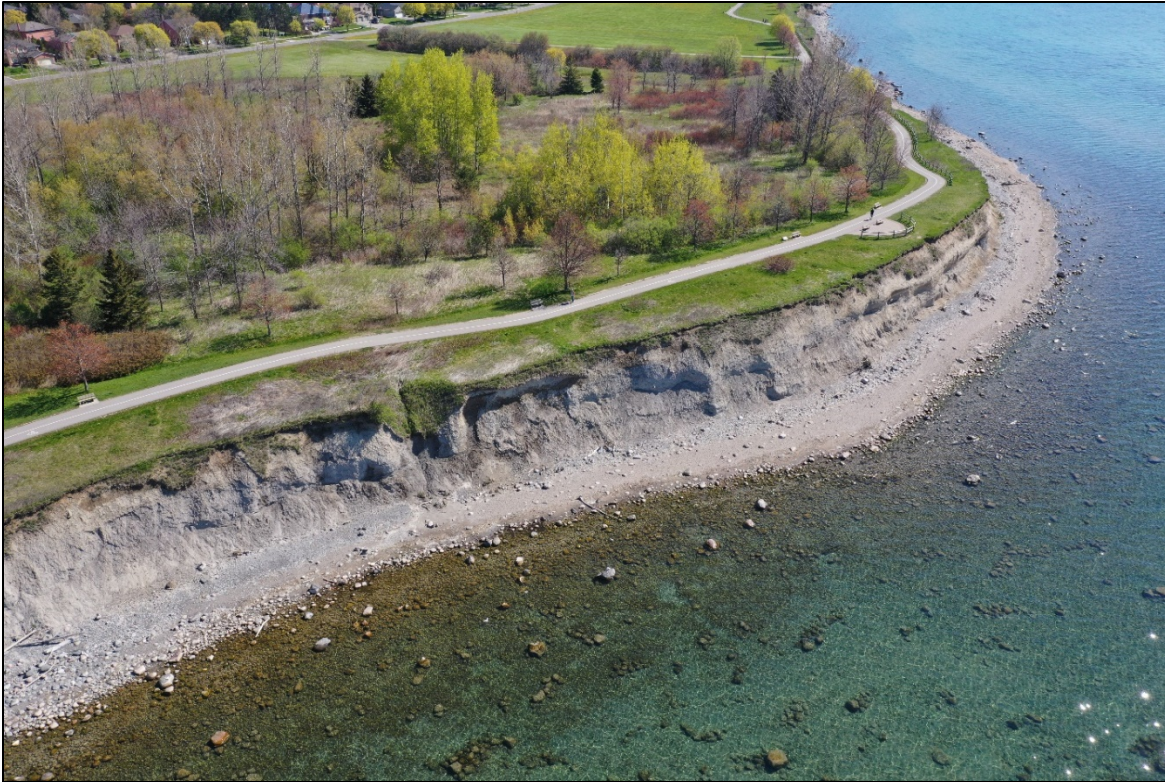
**Figure 3.** Aerial view of the shoreline at Lion's Point, near Rotary Park. *Source: TRCA, 2021.*

The small bluffs and sand and cobble beaches are the most significant natural features in the area. These bluffs and beaches (Figure 3 and Figure 5) are evident along the waterfront for 5.7 kilometers. Figure 10 shows the approximate locations of bluffs and beaches along the shoreline.

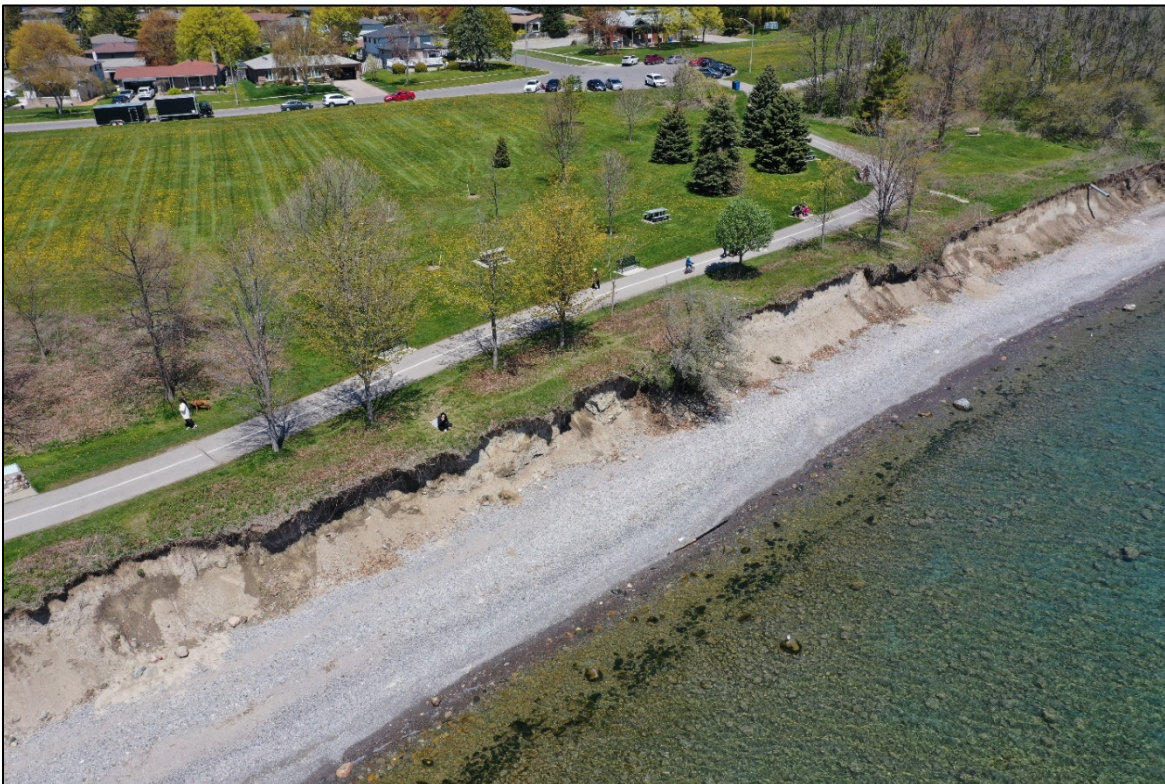
**Figure 4.** Aerial view of the shoreline at the eastern end of Lake Driveway East. *Source: TRCA, 2021.*

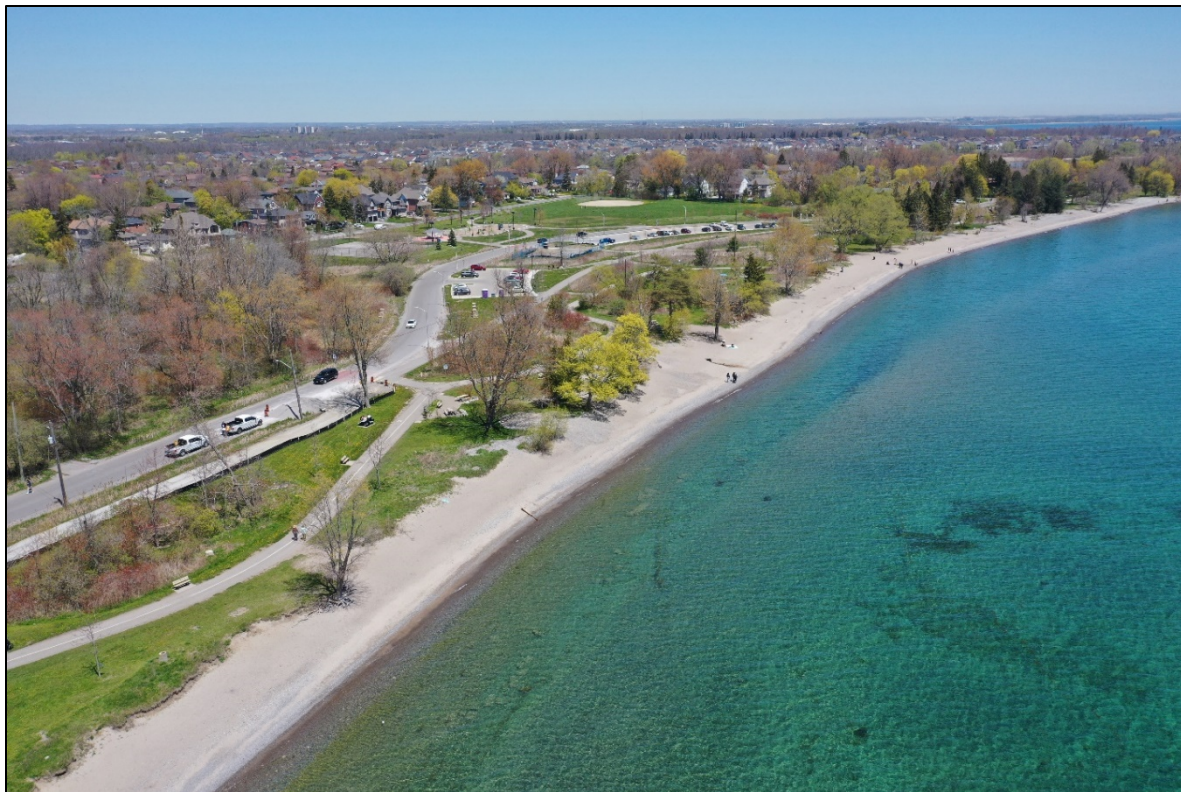
**Figure 5.** Aerial view of Paradise Beach and Park located between the bases of Pickering Beach Road and Shoal Point Road. *Source: TRCA, 2021.*

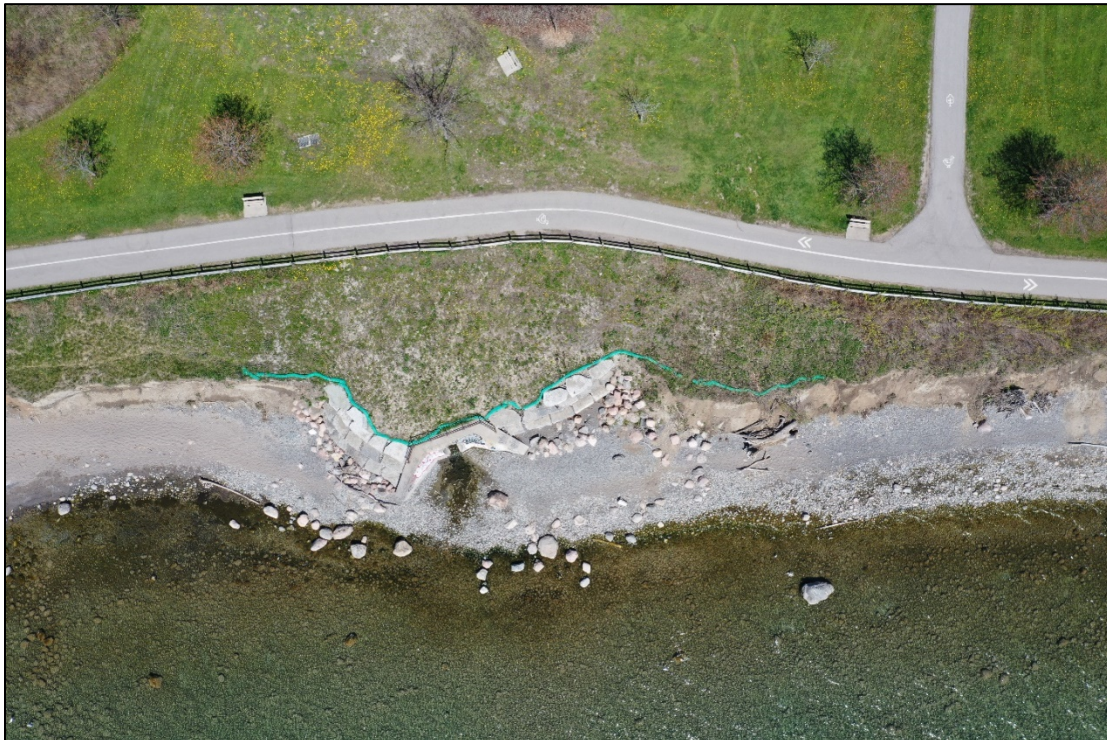
**Figure 7.** Aerial view of headwall repair conducted in 2020. *Source: TRCA, 2021.*

In 2020, TRCA partnered with the Town of Ajax to repair an unstable outfall structure where the material behind the outfall had eroded and caused the headwall to become exposed. The outfall structure is located west of the Love Crescent Parking Lot. The headwall was back filled and an armourstone structure was installed to stabilize and support the outfall (**Figure 7** and **Figure 8**). TRCA has also partnered with Town of Ajax in 2021 to implement a new boardwalk to connect Rotary Park to the existing Duffins Creek bridge (**Figure 9**). The new boardwalk was designed to address the flooding and erosion issues that have been experienced along the previous gravel path.

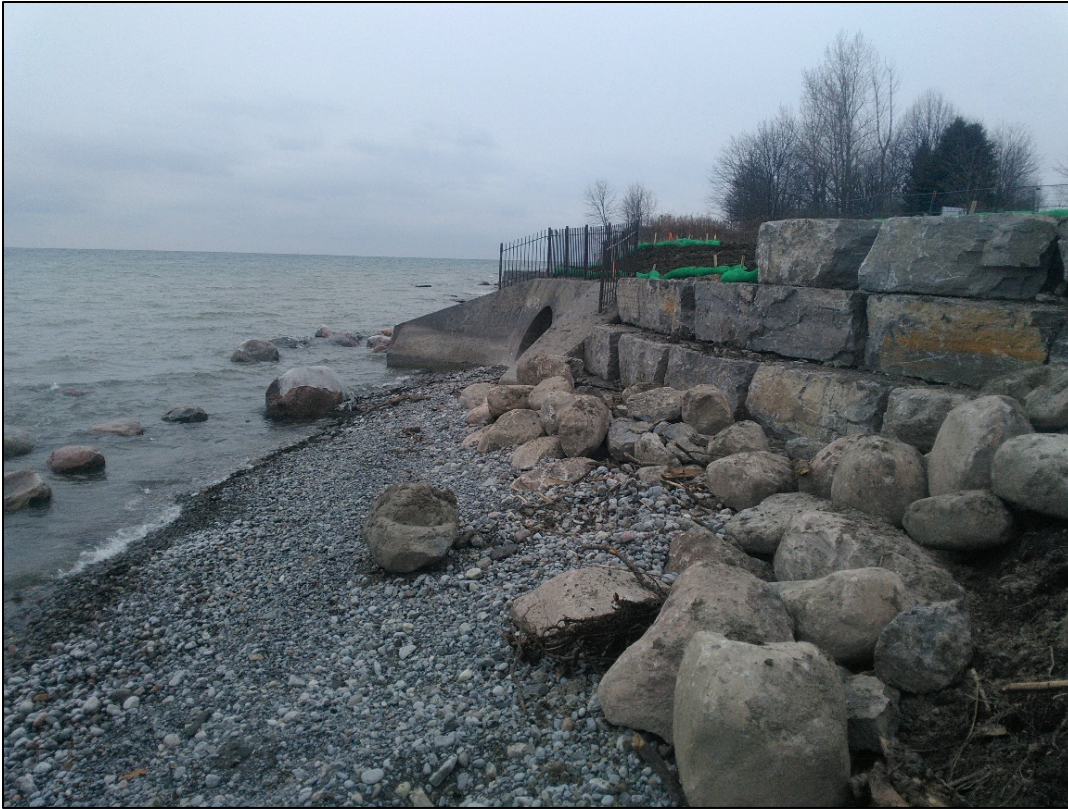
**Figure 8.** Shoreline view of headwall repair and armourstone structure from 2020. *Source: TRCA, 2021.*

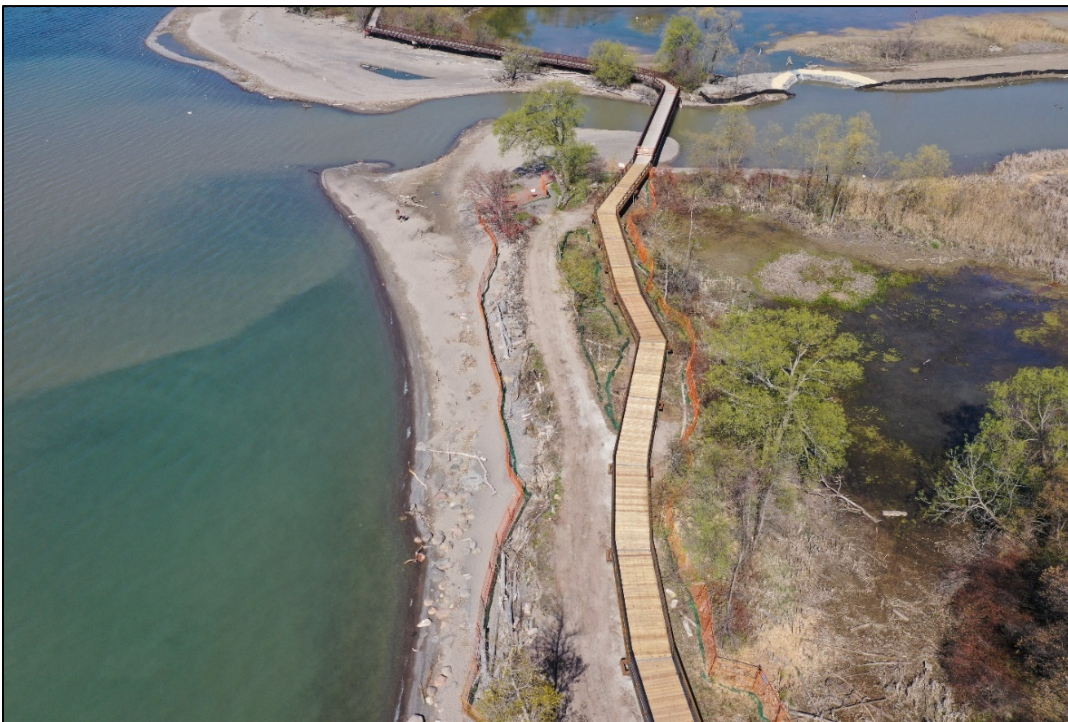
**Figure 9.** Aerial view of the re-designed pedestrian boardwalk that connects to the Duffins Creek bridge. *Source: TRCA, 2021*

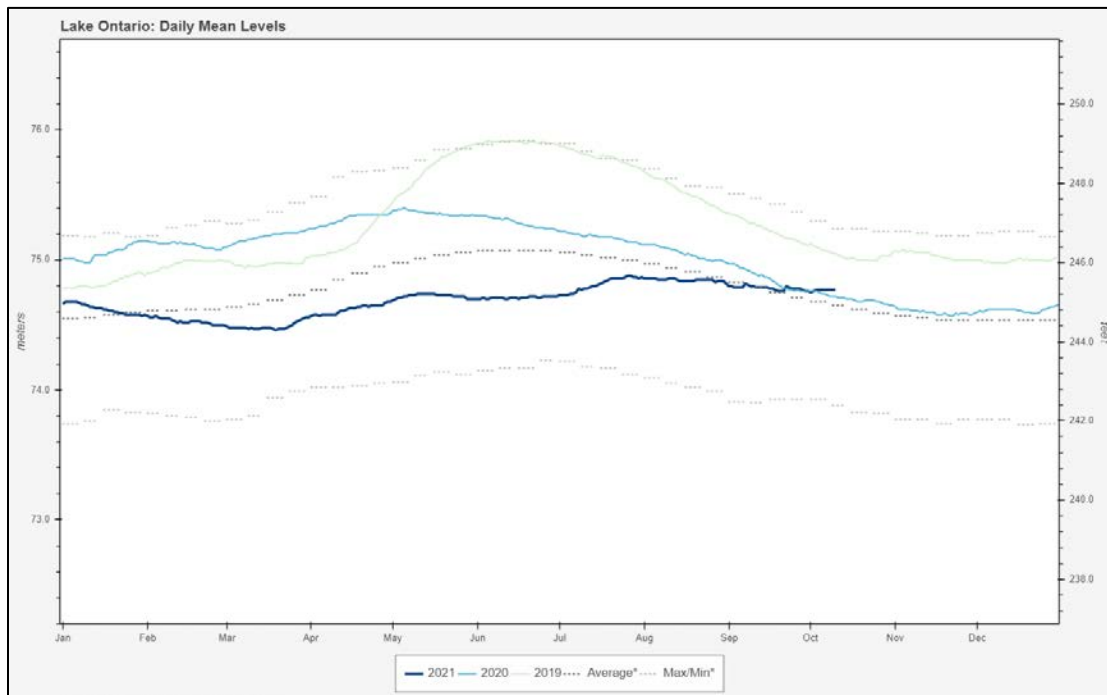
**Figure 12.** Daily water levels of Lake Ontario from 2019 to 2021 to demonstrate the high-water levels in 2019. *Source: International Joint Commission (IJC), 2021.*

In 2017 and 2019, Lake Ontario experienced record high lake level events causing extensive flooding and erosion along the shoreline. **Figure 12** demonstrates the high water levels Lake Ontario experienced in 2019 compared to the water levels of Lake Ontario in 2020 and 2021.

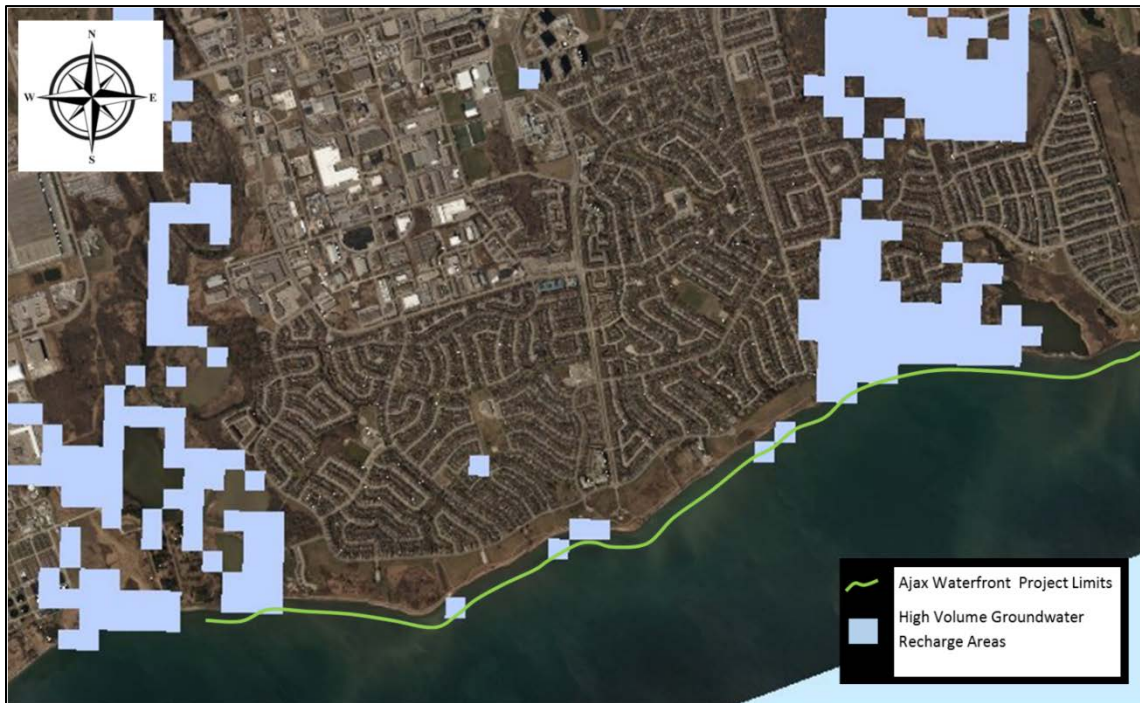
Duffins Creek and Paradise Park are the two major areas that contribute to the High Volume Groundwater Recharge Areas (HVGRA) located within the project limits (**Figure 13**). A few of the outfalls along the shoreline were also identified as HVGRAs.

**Figure 13.** Groundwater recharge areas near and within the project area. *Source: TRCA, 2021.*

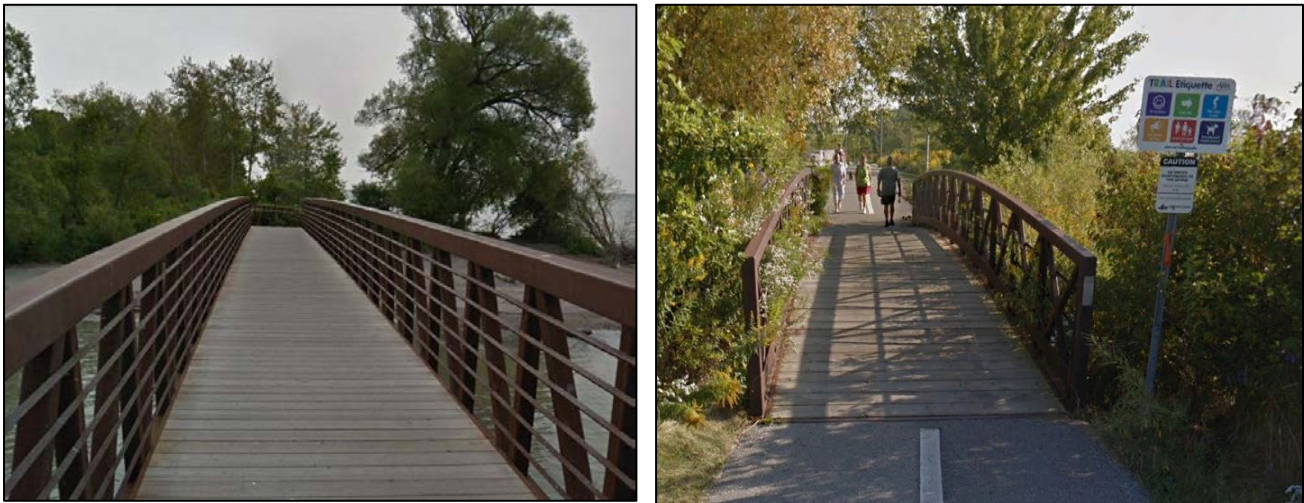
**Figure 14.** The boardwalk at Duffins Creek and the pedestrian crossing located west of the Ajax Water Supply Plant. Source: Google Earth, 2021.

There are pedestrian crossings along the project limit. The constructed crossing on the west end of the project area is the boardwalk from Rotary Park to Duffins Creek. There is also a small pedestrian bridge on the Waterfront Trail that is located to the west of the Ajax Water Supply Plant.

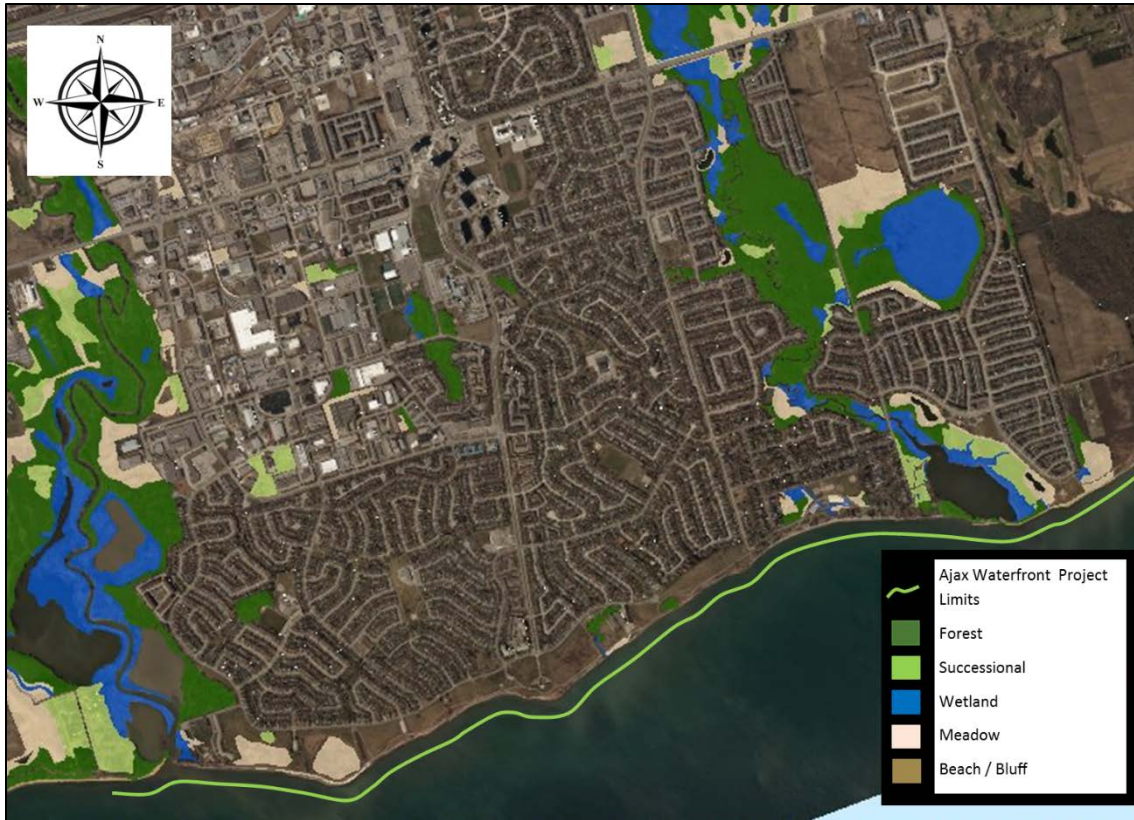
The Project area consists mainly of manicured lawn, parks and greenspace for public use. There are a few potential wildlife habitat areas that have been identified by the natural cover data (**Figure 15**). Along with manicured greenspaces, there are wetlands, small forested areas and meadows. These small forested areas may provide breeding and nesting habitat for birds and provide shelter for terrestrial fauna. Duffins Creek, Caruthers Marsh and Paradise Park provide wetland habitat for multiple terrestrial and aquatic species. Along with these identified areas, the shoreline itself can provide wildlife habitat for multiple bird species and other local fauna.

**Figure 15.** Location of natural cover data that was collected in 2017. *Source: TRCA, 2021.*

There are three wetlands located within the project area. From west to east, there is: Duffins Marsh, Paradise Park Wetlands and Carruthers Marsh. These wetlands are identified in **Figure 15** where the natural cover of the Ajax waterfront is outlined. These wetlands provide a diverse ecosystem for multiple terrestrial and aquatic species. Wetlands also contribute to promoting the water quality by filtering the water and allowing sediment to deposit before entering Lake Ontario. The Lake Ontario SMP notes that preserving barrier beaches will help protect wetlands from wave action.

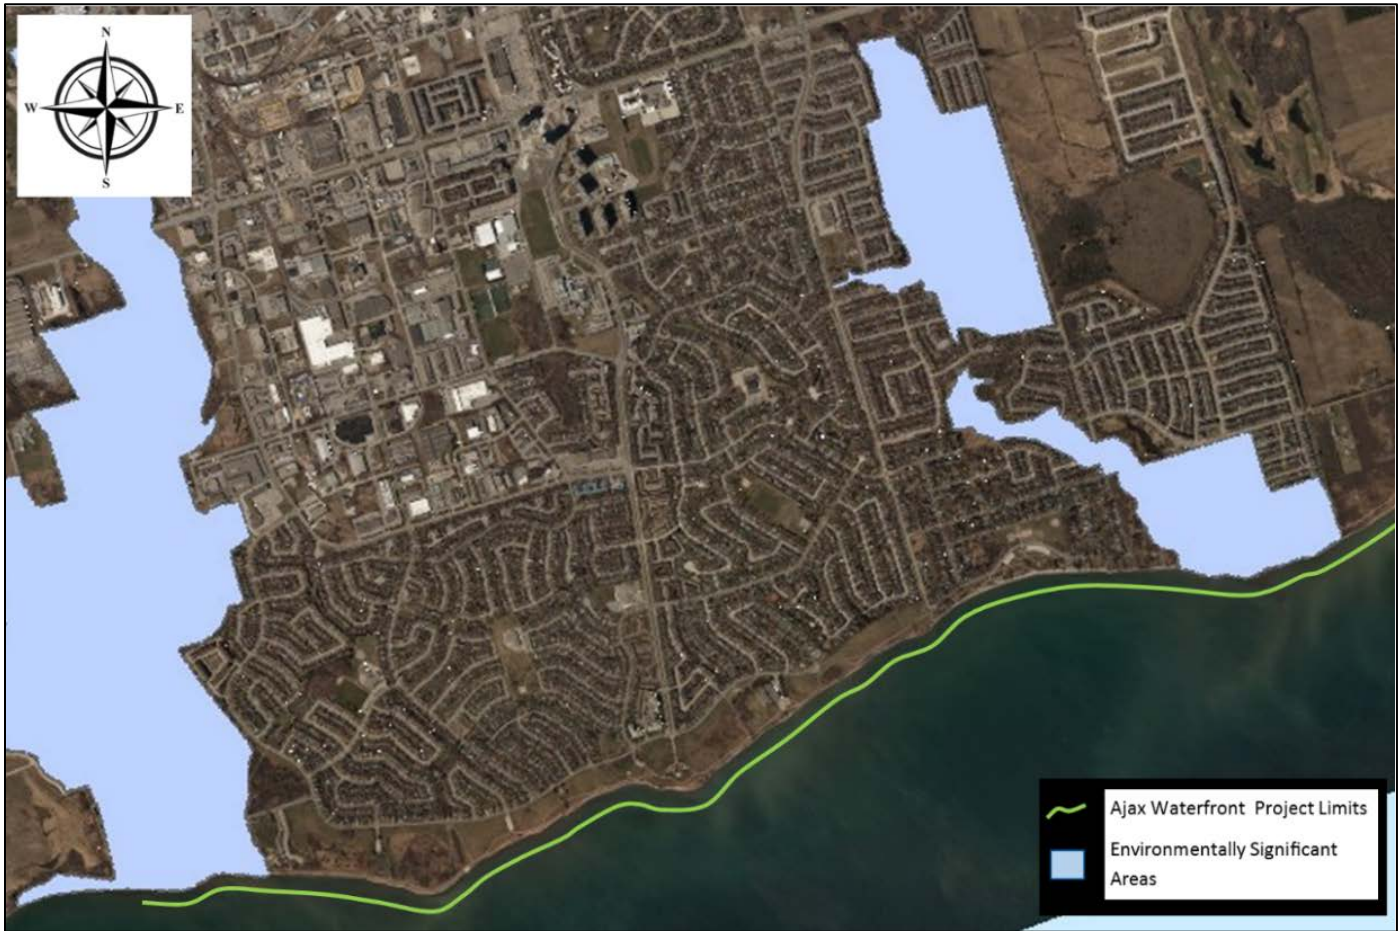
ESAs are defined as areas of land that meet one or more certain physical or biological criteria. Duffins Creek and Carruthers Marsh have been identified as ESAs (**Figure 17**). These ESAs have also been identified as Provincially Significant Wetlands and are shown in **Figure 18**.

**Figure 17.** ESAs along the Ajax waterfront. *Source: TRCA, 2021.*

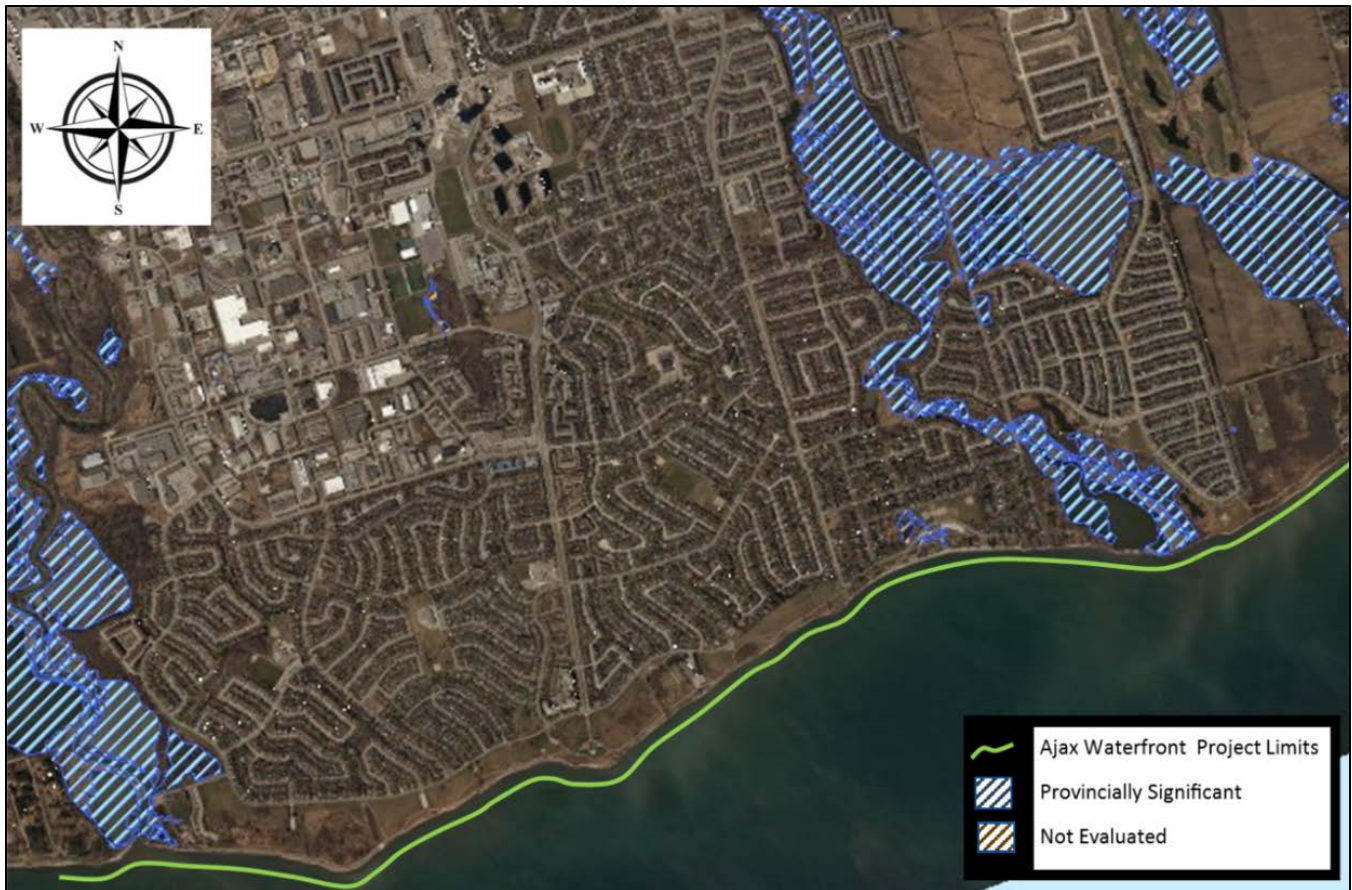
**Figure 18.** Provincial Significant Wetlands that have been identified within the project limits. *Source: TRCA, 2021.*

There are two Provincially Significant Wetlands (**Figure 18**) that provide unique habitats to multiple species that are not common in other parts of the project area. Any impacts to these habitats will be assessed during the Class EA Report.

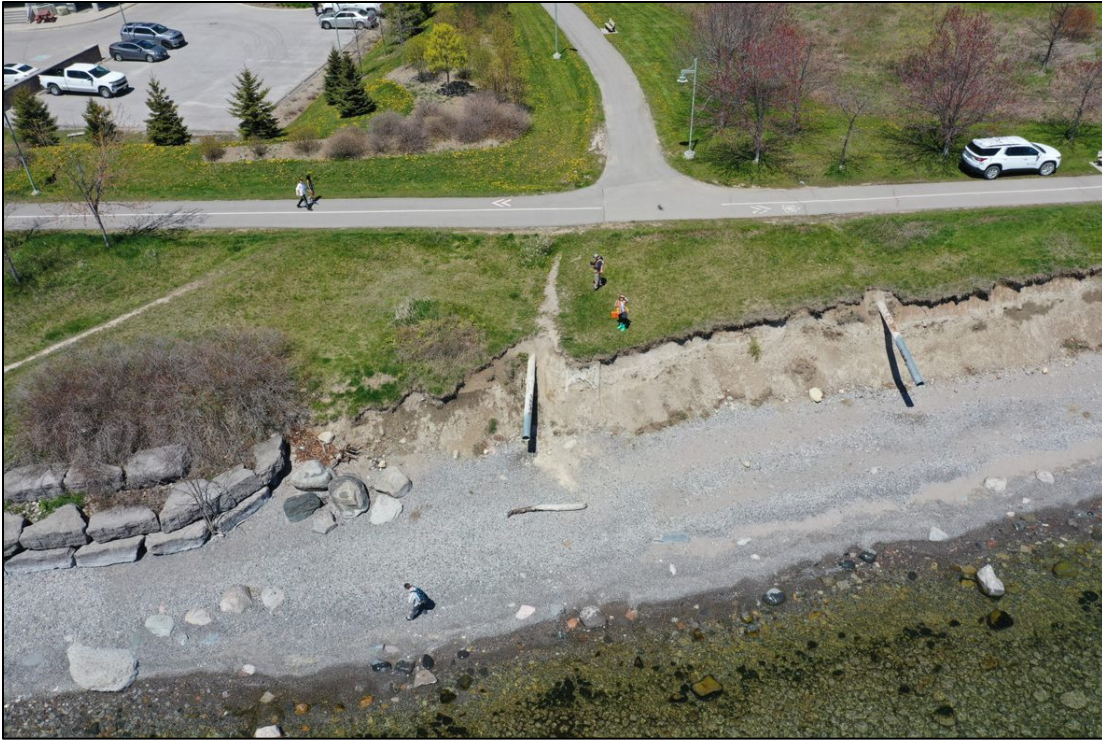
**Figure 23.** Infrastructure exposed along the Ajax waterfront. *Source: TRCA, 2021.*

Through the use of GIS data provided by the Town of Ajax, TRCA assessed the exposure and consequence of failure for underground infrastructure, trails, sidewalks, lighting, municipal buildings, trees and other existing structures along the Ajax waterfront to determine erosion risks. The proximity to these items (the Waterfront Trail, existing light fixtures, existing benches, and existing buried infrastructure) was considered in identifying locations for erosion hazard monitoring.

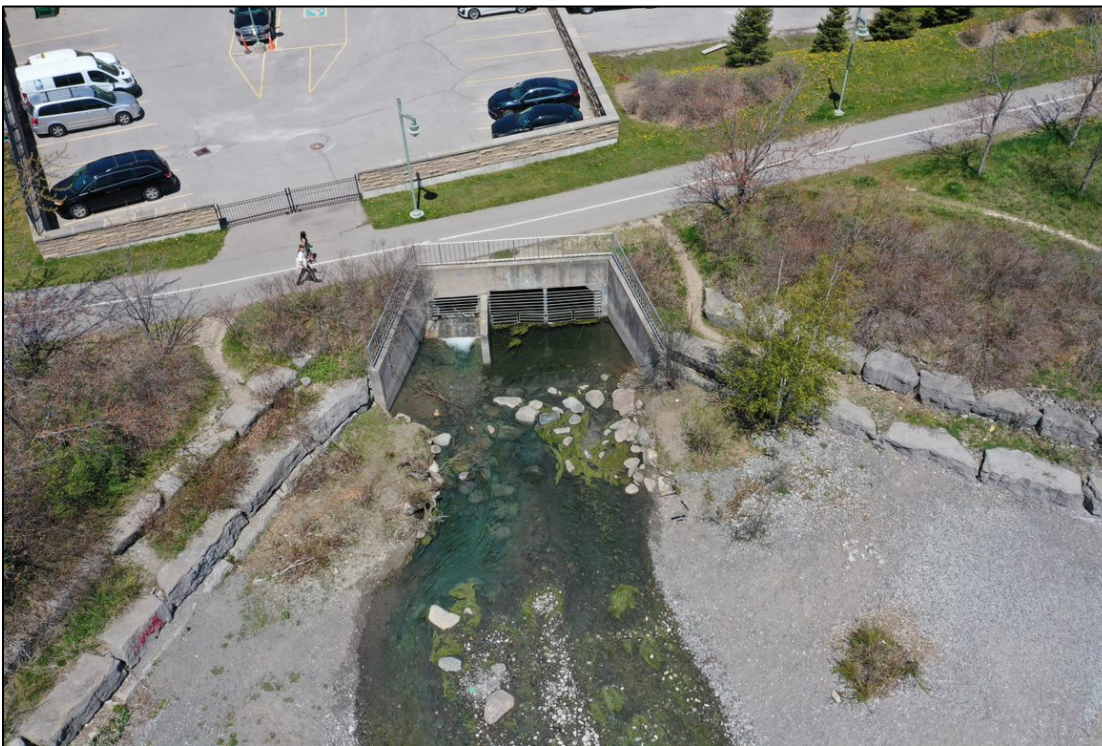
**Figure 24.** Stormwater outfall located near the Ajax Water Supply Plant. *Source: TRCA, 2021.*

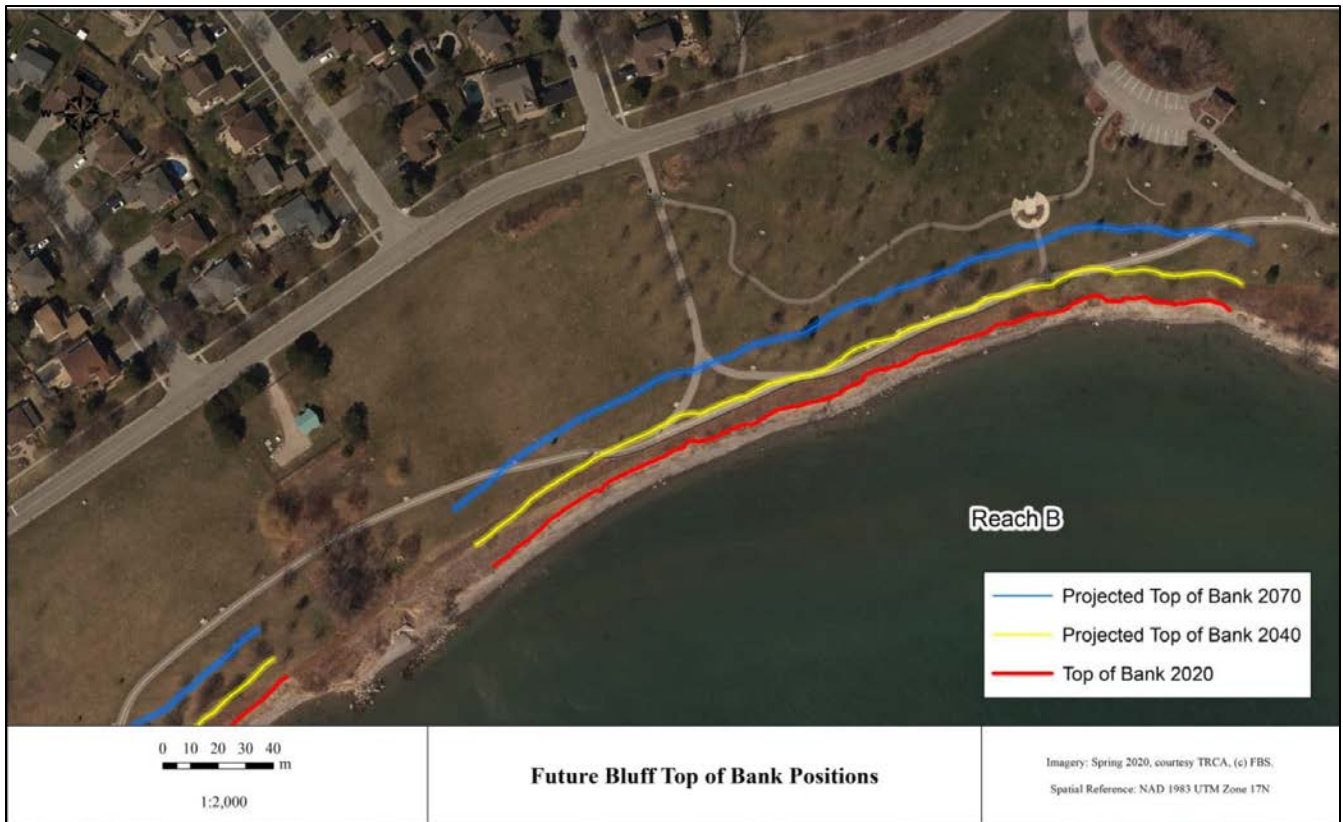
**Figure 26.** Top of bank projections for Reach B. *Source: Baird, 2021.*

The short-term erosion rates are higher and more variable than the long-term erosion rates and can be used to show the areas most likely to experience more aggressive erosion, called “hot spots”. Baird also provided examples of the projected top of bank location for 2040 and 2070 using their assessment. These locations are shown in **Figure 26**. Note that these projections are limited as they do not consider the stable slope position, which would require physical data collection (i.e. boreholes) to fully identify. These protections assume no shoreline protection is implemented and would be considered a “do nothing” option.

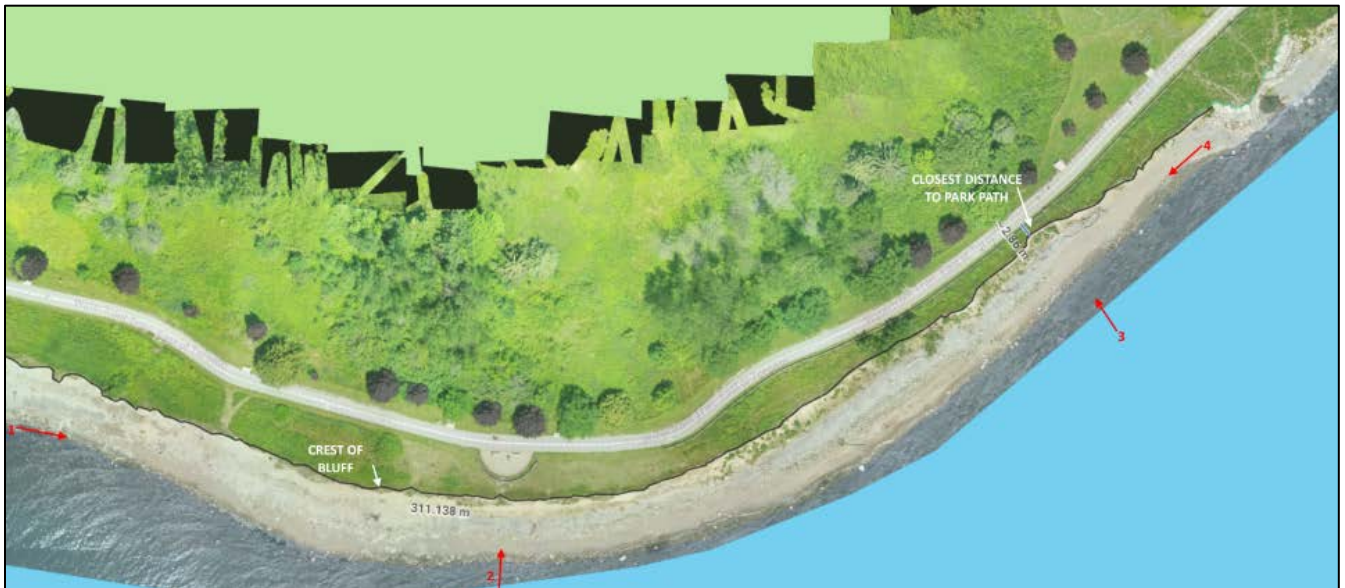
**Figure 30.** 3D model of RPAS photogrammetry data used to create a plan view of the deficiencies and photo locations for Site E (EMS983). *Source: TRCA, 2021.*

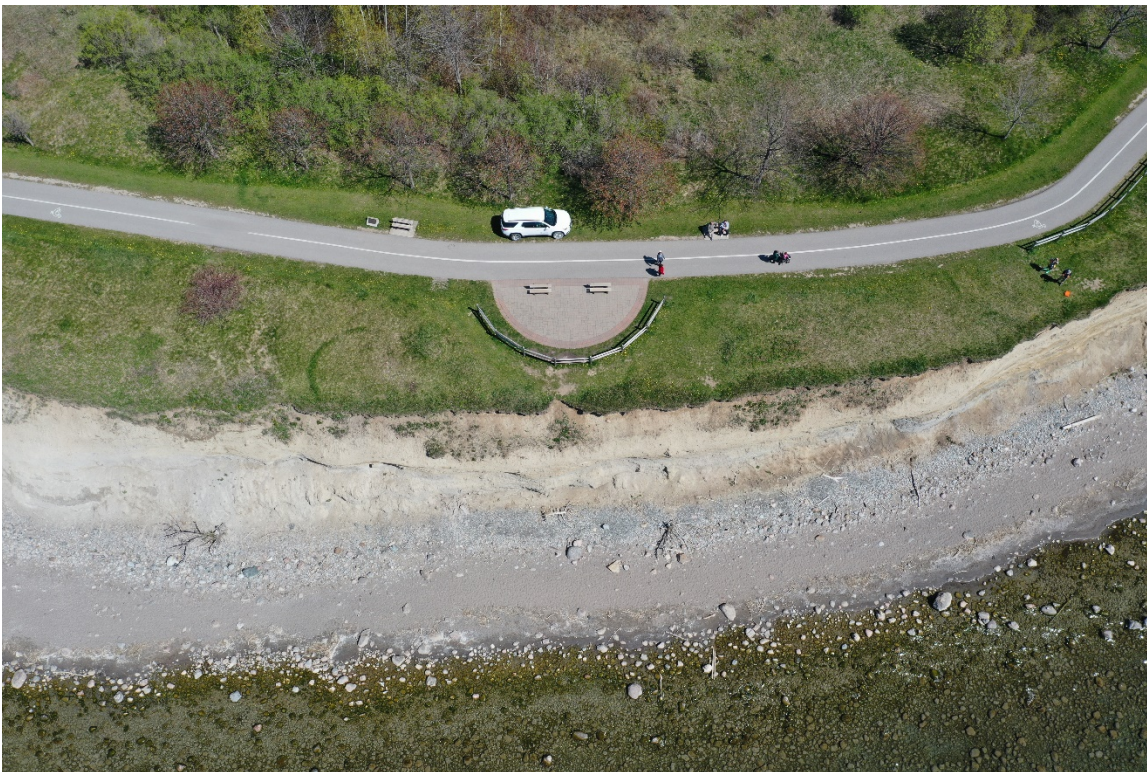
**Figure 32.** Photo of monitoring station B for Site E (EMS983) using RPAS technology. *Source: TRCA, 2021.*
