# Ajax Waterfront Project

Environmental Assessment and Conceptual Design Development

April 5, 2023 | 13804.101.R1.RevB

W.F. Baird & Associates Coastal Engineers Ltd

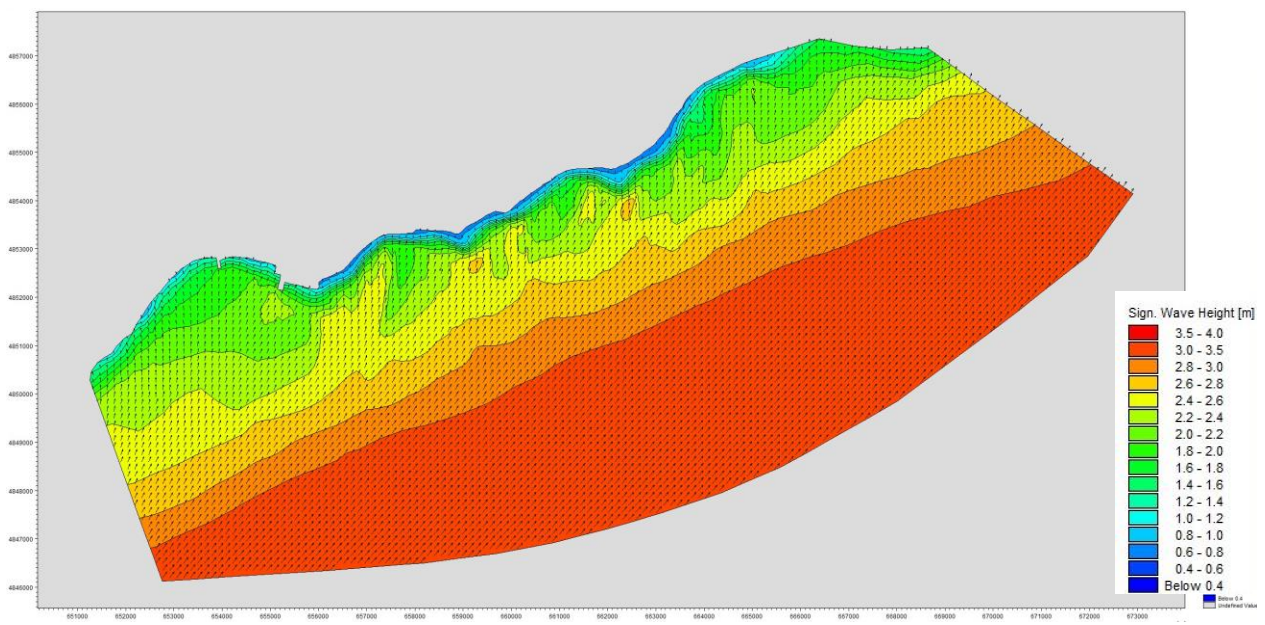
Figure 2.1: Example of SW Storm Condition in M21SW Model

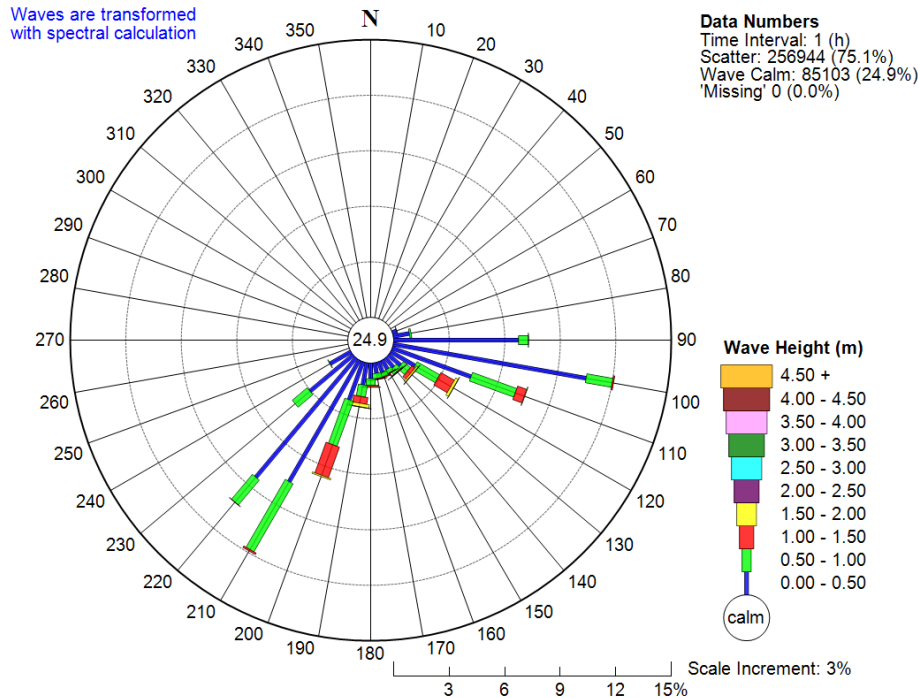
An overview of the wave conditions approaching the shoreline is provided in the wave rose shown in Figure 2.2.

**Figure 2.2: Nearshore Wave Conditions (6 m water depth, 155° shoreline azimuth)**

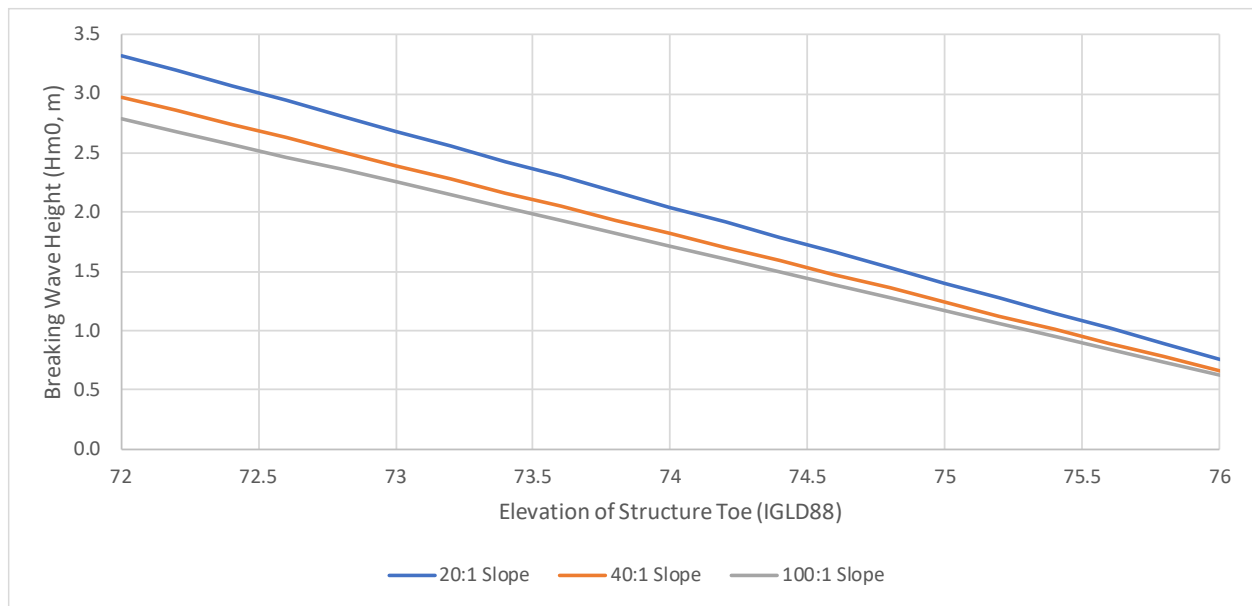
After transformation over the shallow nearshore area, the waves that will impact the structures can be determined based on the water depth and the nearshore slope. Goda (2000) provides a simple but reasonable estimate of the significant breaking wave height in depth limited conditions. Figure 2.3 shows the significant (average of the highest one-third of the waves in a sample of waves) wave height as a function of nearshore slope and toe elevation, based on a 100-year water level (76.2 m). A slope of 100:1 is a reasonable approximation for most of the region, although some steeper slopes may occur very close to the beach face.

**Figure 2.3: Breaking Wave Height in Shallow Water from Goda (2000)**

Structures must be designed to consider the present day water depth, plus an allowance for nearshore downcutting. For example, an offshore structure where the slope is 100:1 and the toe depth is at 73.5 m (0.7 m below low water datum) might be designed for a toe elevation of 73.0 m to accommodate downcutting. This means that the significant breaking wave height would be about 2.20 m. Note that all of these calculations assume an offshore wave height of 5 m and a period of 9 s. A reduction in the offshore wave height from 5 m to 4 m results in a reduction in the nearshore wave height of only about 6 cm (2.22 m vs. 2.16 m). Therefore, slight variations in offshore wave height are not important in these depth limited conditions.

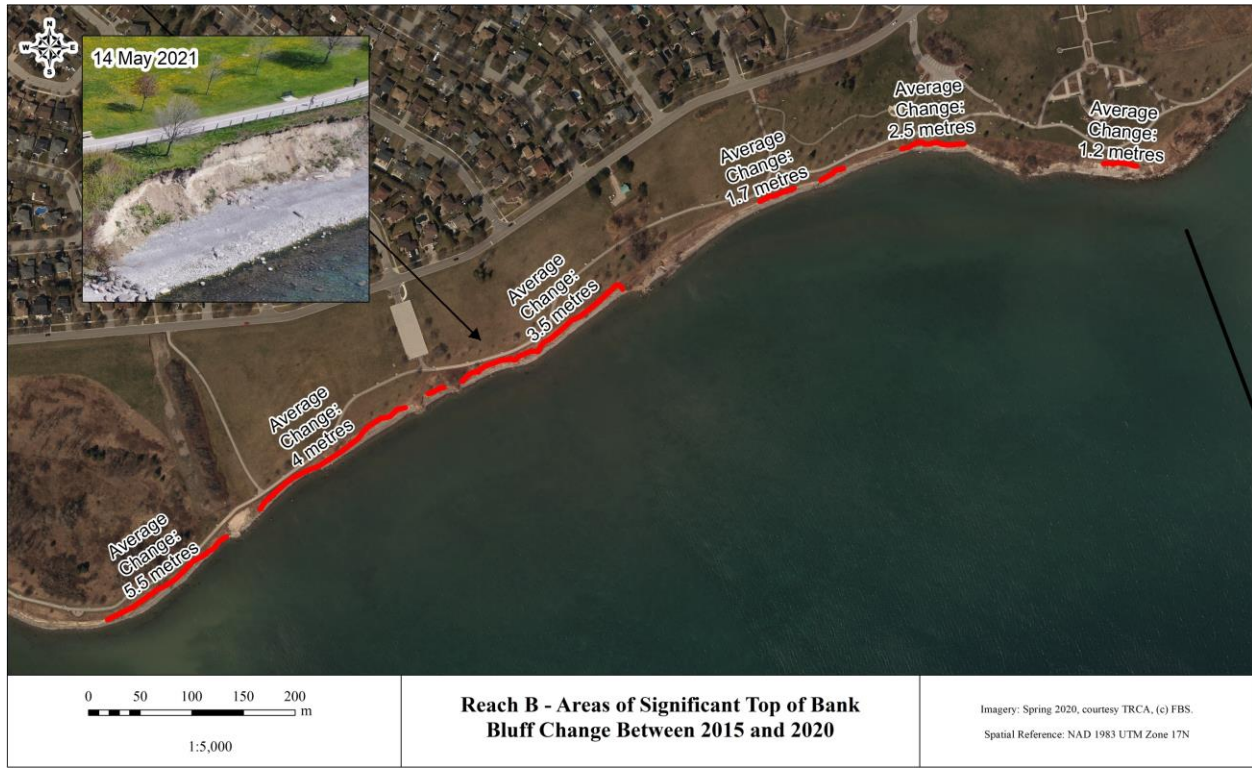
With very high water levels in 2017 and 2019, additional comparisons were completed to document locations where there had been significant recession of the shoreline between the 2015 LiDAR and 2020 aerial photography. Most of the areas that showed the greatest recession were in Reach B (Figure 2.5), with some areas averaging over 1 m per year during that five-year span. Many of the bluffs may have been over-steepened through toe erosion during high water levels and a higher rate of erosion could persist in the following years as the bluffs gradually stabilize. The long term erosion rate is determined through a much greater interval than just a few years of high water levels, resulting in a more meaningful long term average that spans a range of water levels.

Figure 2.5: Reach B Recession from 2015 to 2020

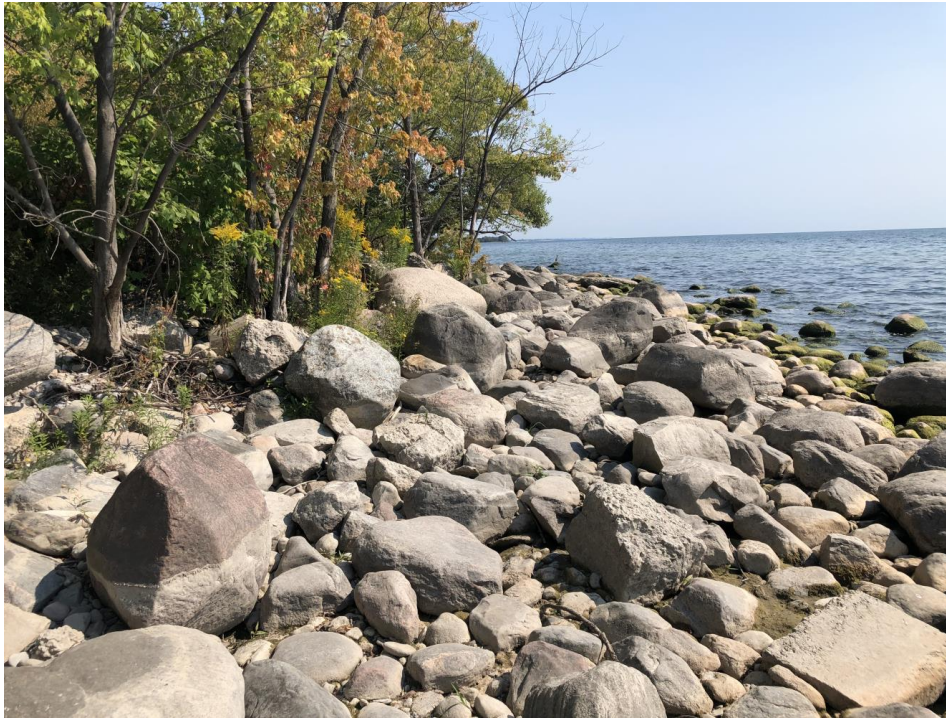
structures. The natural cobble/boulder beach at the base of Veteran's Point (Figure 3.4) is an example of the type of material that would be stable at this site.

**Figure 3.4: Natural Cobble/Boulder Beach at Veteran's Point**

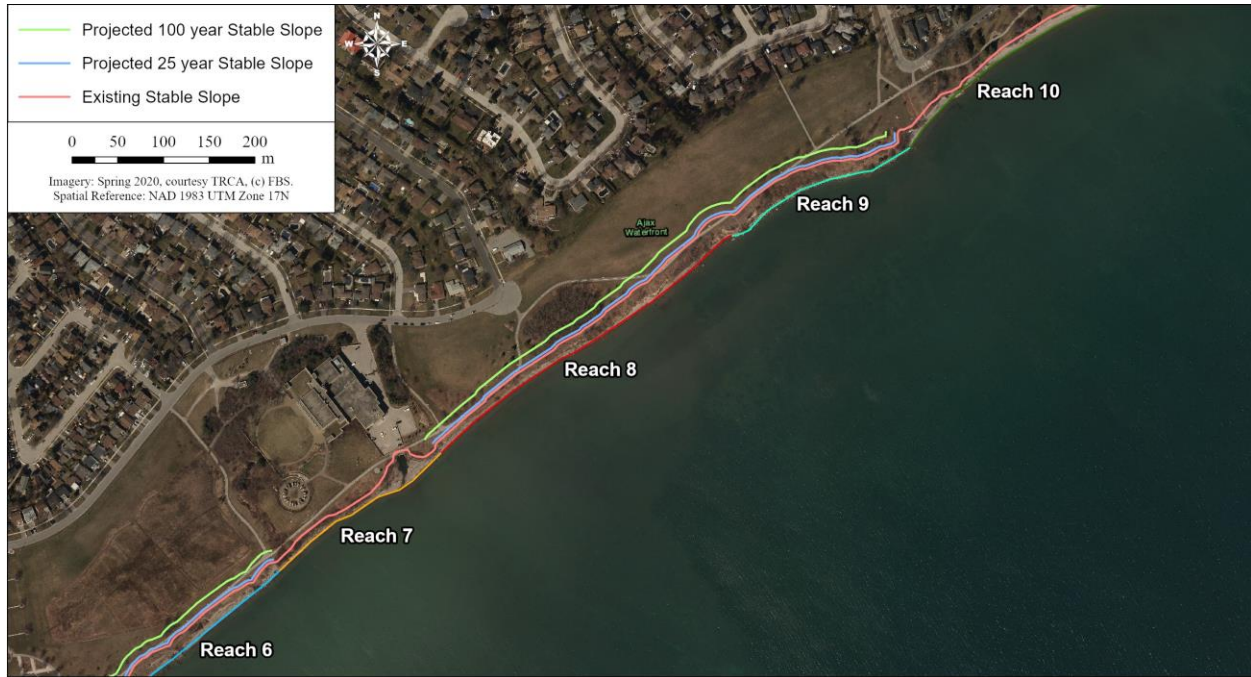
**Figure 4.4: Projected Future Bluff Stable Slope for Reaches 7 to 9**

To better understand the future risk to infrastructure, the projected alignment of the bluff crest was plotted and is shown in Figure 4.2 through Figure 4.5. Reaches 2, 10 and 11 were omitted from this assessment as they do not have a defined erosion rate. Reach 7, at the water treatment plant, was also omitted as there is significant protection at this location and future maintenance of the revetment to protect the water treatment plant is almost certainly going to occur. The plot shows the immediate need to protect reaches 3 and 5 where

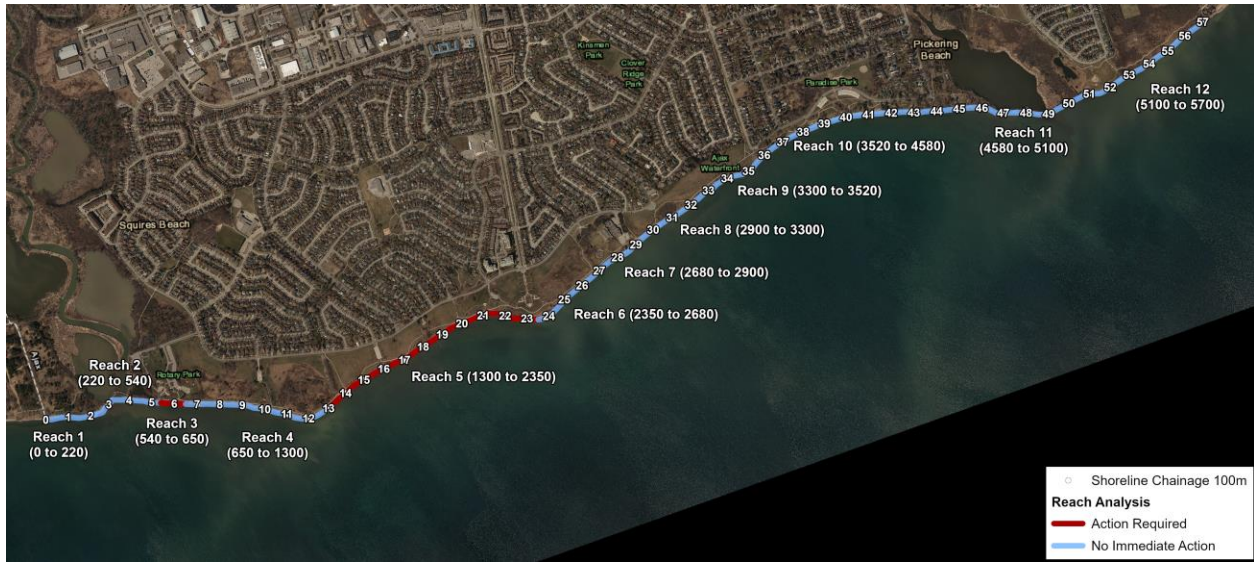
Table 4.4 provides a summary of the recommended concept by reach, while additional discussion is provided in Appendix A. For each reach, two concepts are listed, with the first being the preferred approach. These recommendations are preliminary and are subject to change in response to environmental inputs, stakeholders inputs and longer term changes to priorities and costs. The two creek mouths are defined as “do nothing”; Paradise Beach (reach 10) has “do nothing” as the first choice and a nearshore reef as the second choice. An overview of the proposed near-term protection for the Ajax shoreline is provided in Figure 4.6.

**Figure 4.6: Proposed Near-Term Protection of Ajax Shoreline**

These 12 reaches are significantly more than what was described in the terms of reference, where five reaches were suggested. To better align the reaches with the proposed level of detail for the environmental assessment, the 12 reaches can be collapsed into six reaches. This is done by ignoring the three “do nothing” reaches (two creek mouths and Paradise Beach) and then combining adjacent reaches with the same primary preferred concept. This means that the reaches become: 1, 3, 4+5, 6+7+8, 9, 12.

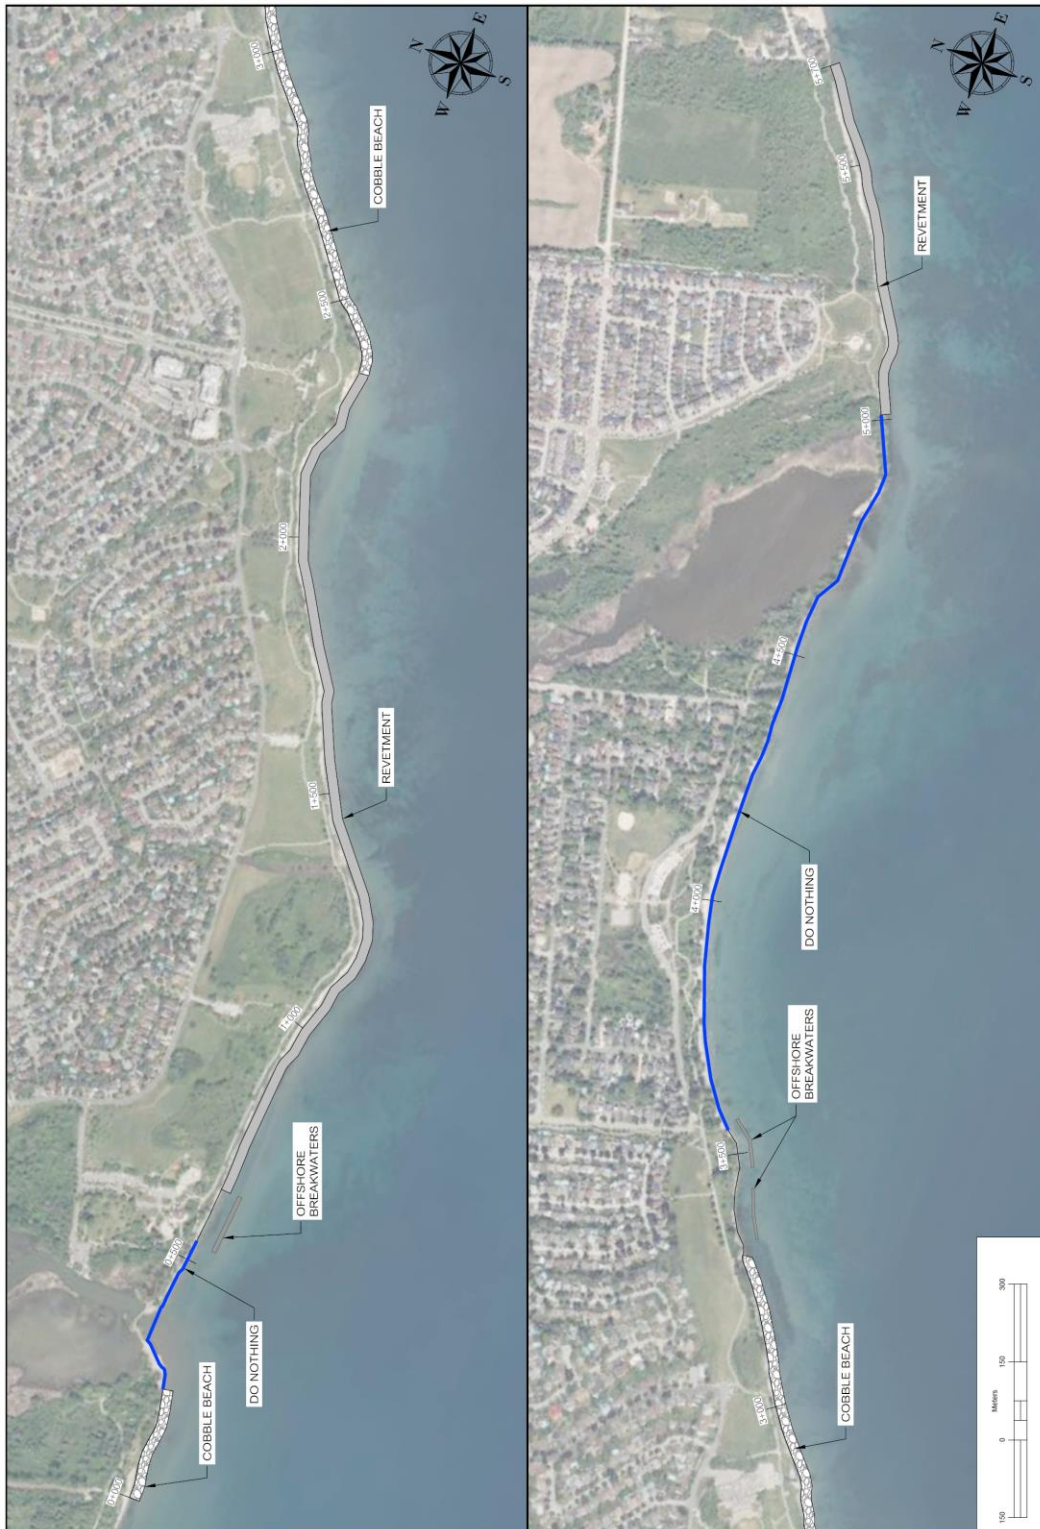
Figure 4.7: Overview of Preferred Concepts by Reach

An overview of the preferred concepts is shown in Figure 4.7. For many of these reaches, it may be decades before protection is required. Therefore, the protection shown in Figure 4.7 should not be considered to be a near-term plan.
